INVESTIGATION OF BREEDING PEREGRINE FALCONS ON BRIDGES

Watts, B. D. and M. U. Watts. 2017. Investigation of breeding peregrine falcons on bridges. The Center for Conservation Biology. Technical Report Series, CCBTR-17-01. College of William and Mary & Virginia Commonwealth University, Williamsburg, VA. 38 pp.

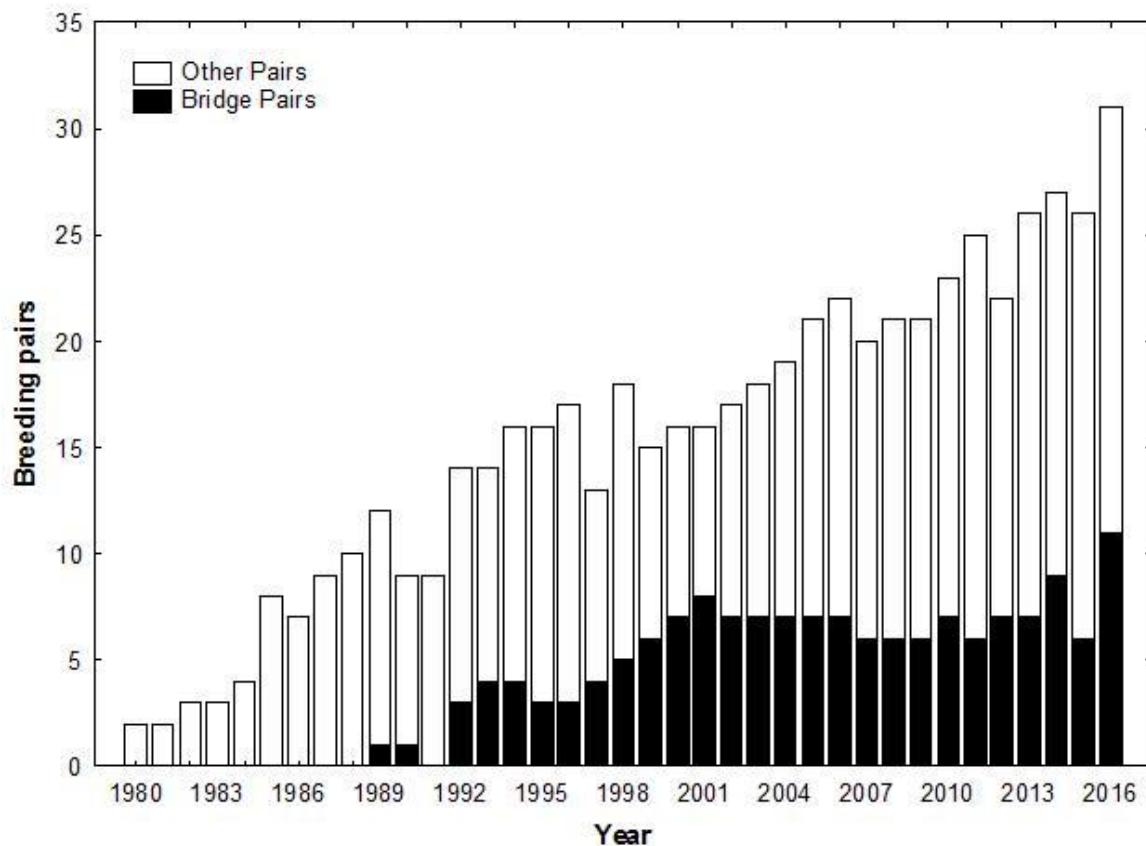
Figure 1 The number of breeding pairs of peregrine falcons in Virginia (1980-2016). Dark bars represent pairs nesting on bridges and open bars represent pairs on all other structures. Data from The Center for Conservation Biology archives.

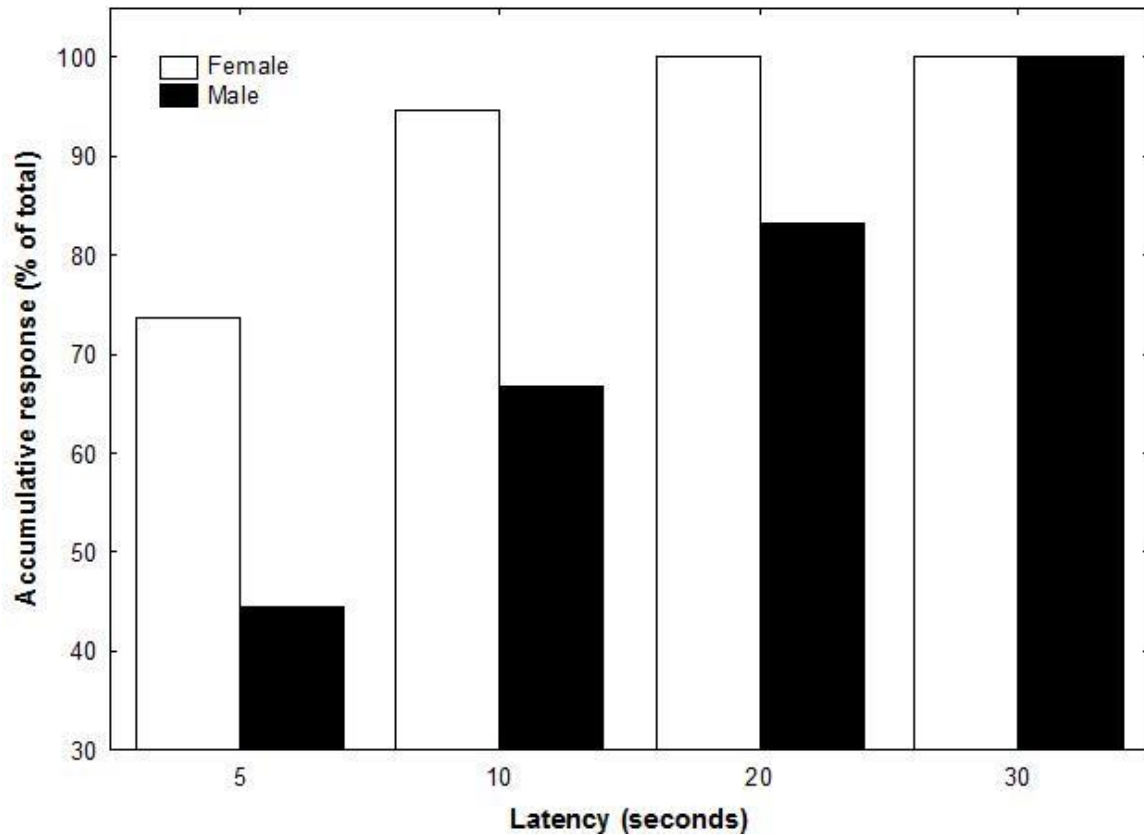
Figure 3. Latency in the response of peregrine falcons to call-broadcasts near bridges. Responses during first and second surveys are combined. Time intervals indicate the number of seconds since the initiation of broadcast calls. Data are presented as accumulated values reflecting the percentage of responses that have occurred before the end of stated time. Females and males showed significantly different responses.

Response of falcons to tapes varied by gender was nearly immediate and was dramatic (Appendix C). Response rate for females was higher than for males (90.5% vs 80.9%) though this difference was not statistically significant (G-statistic with Yates Correction = 0.04, $df = 1$, $p > 0.5$). Latency in response to taped calls was low. When both males and females are combined, 59.5% of responses were within 5 sec, 81.1% were within 10 sec and all responses occurred within 30 sec of call initiation. Latency for females was significantly (G-statistic with Yates Correction = 0.114, $df = 3$, $p < 0.01$) lower compared to males (Figure 3). Nearly all (97.2%) responses included both calls and flights. Birds typically flew out from the bridge infrastructure toward the caller, circled several times giving the cackle call and then returned to a perch. Males and females often flew out from different perches on the bridge but perched together following responses. On one occasion a female flew directly to a perched male and dislodged him from a hidden location and elicited a response. On three occasions males flew to the nest site and initiated courtship displays (bowing and strutting).

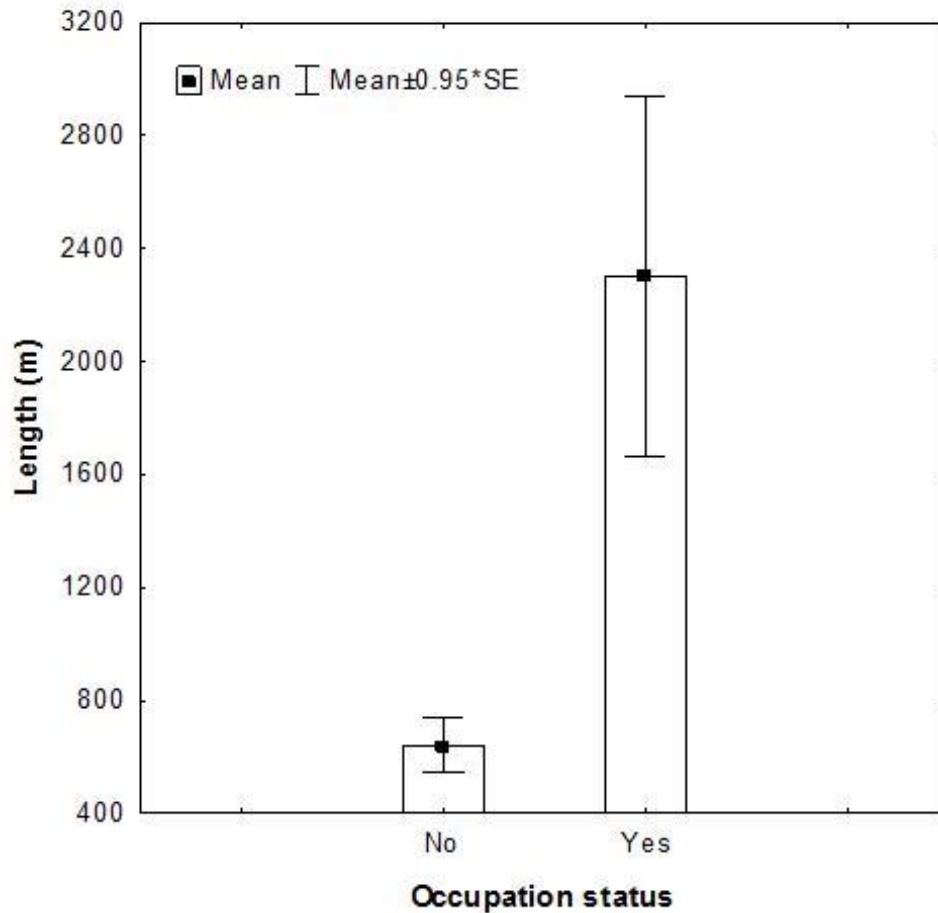
Figure 6. Comparison of mean length between bridges documented to support peregrine falcon pairs during the 2016 breeding season and bridges not known to support pairs.

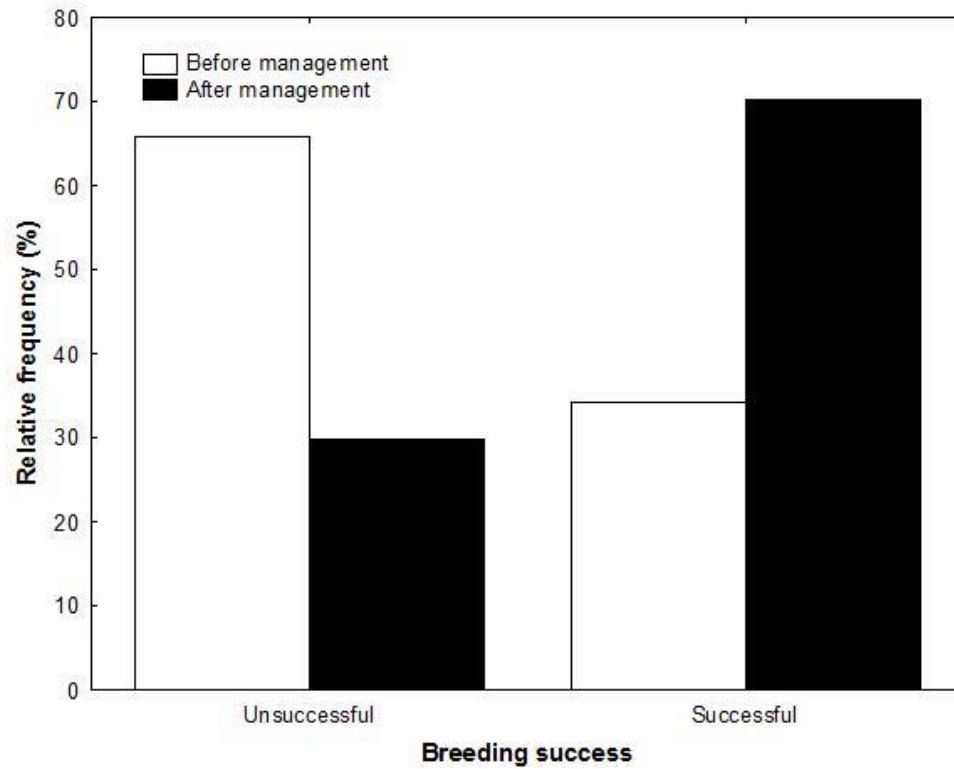
Figure 7. Comparison of peregrine falcon breeding success before ($n = 38$) and after ($n = 117$) management activities on bridges in Virginia. Breeding attempts used in the analysis included 12 bridges. Data from The Center for Conservation Biology archives.

The installation of management structures (nest box or nest tray) on bridges for use by nesting falcons has had a positive influence on breeding performance. Breeding success was significantly (G-statistic with Yates Correction = 61.7, df = 1, $p < 0.001$) higher (70.1 vs 34.2%) following the installation of management structures compared to before installation (Figure 7). In addition to an increase in breeding success, pairs nesting on management structures produced significantly (Mann-Whitney U statistic = 1,428.5, $Z = -3.4$, $p < 0.001$) more young compared to pairs nesting without such structures. Pairs nesting within boxes or on trays produced more than twice as many young compared to those that did not (Figure 8).

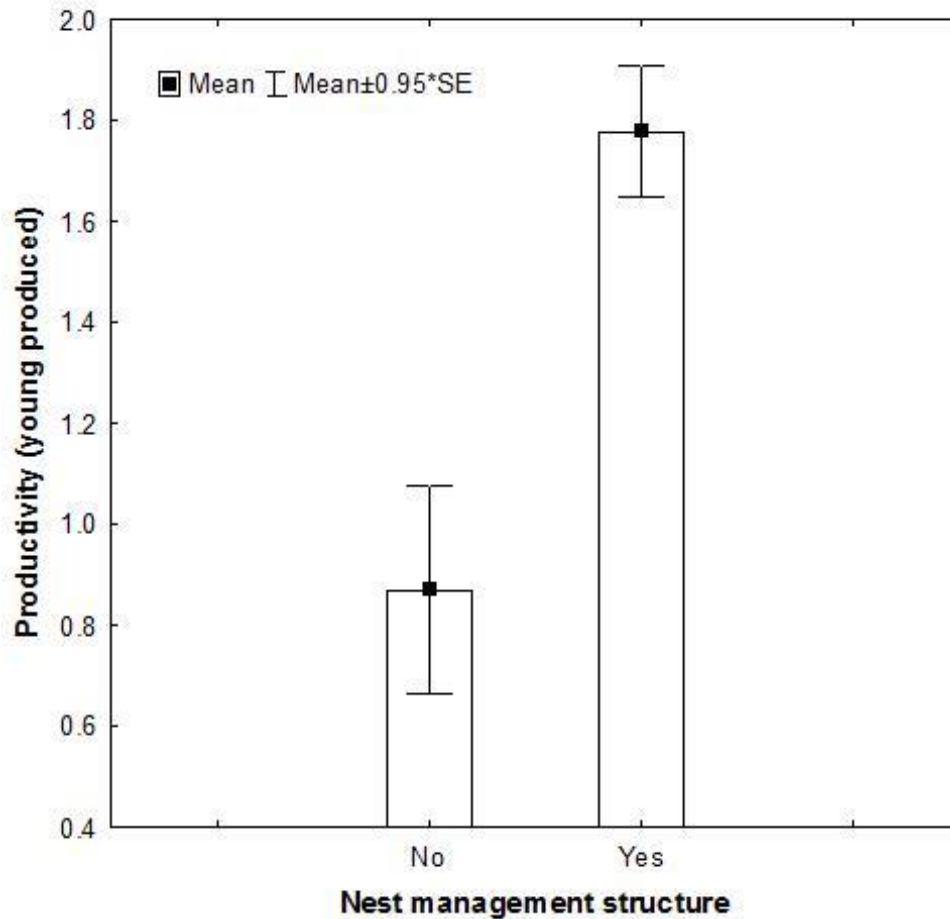
Figure 8. Comparison of mean productivity for peregrine falcons before ($n = 38$) and after ($n = 117$) management activities on bridges in Virginia. Breeding attempts used in the analysis included 12 bridges. Data from The Center for Conservation Biology archives.
